# Buckland Hill

## Conservation Management Plan

November 2019 | 18-250

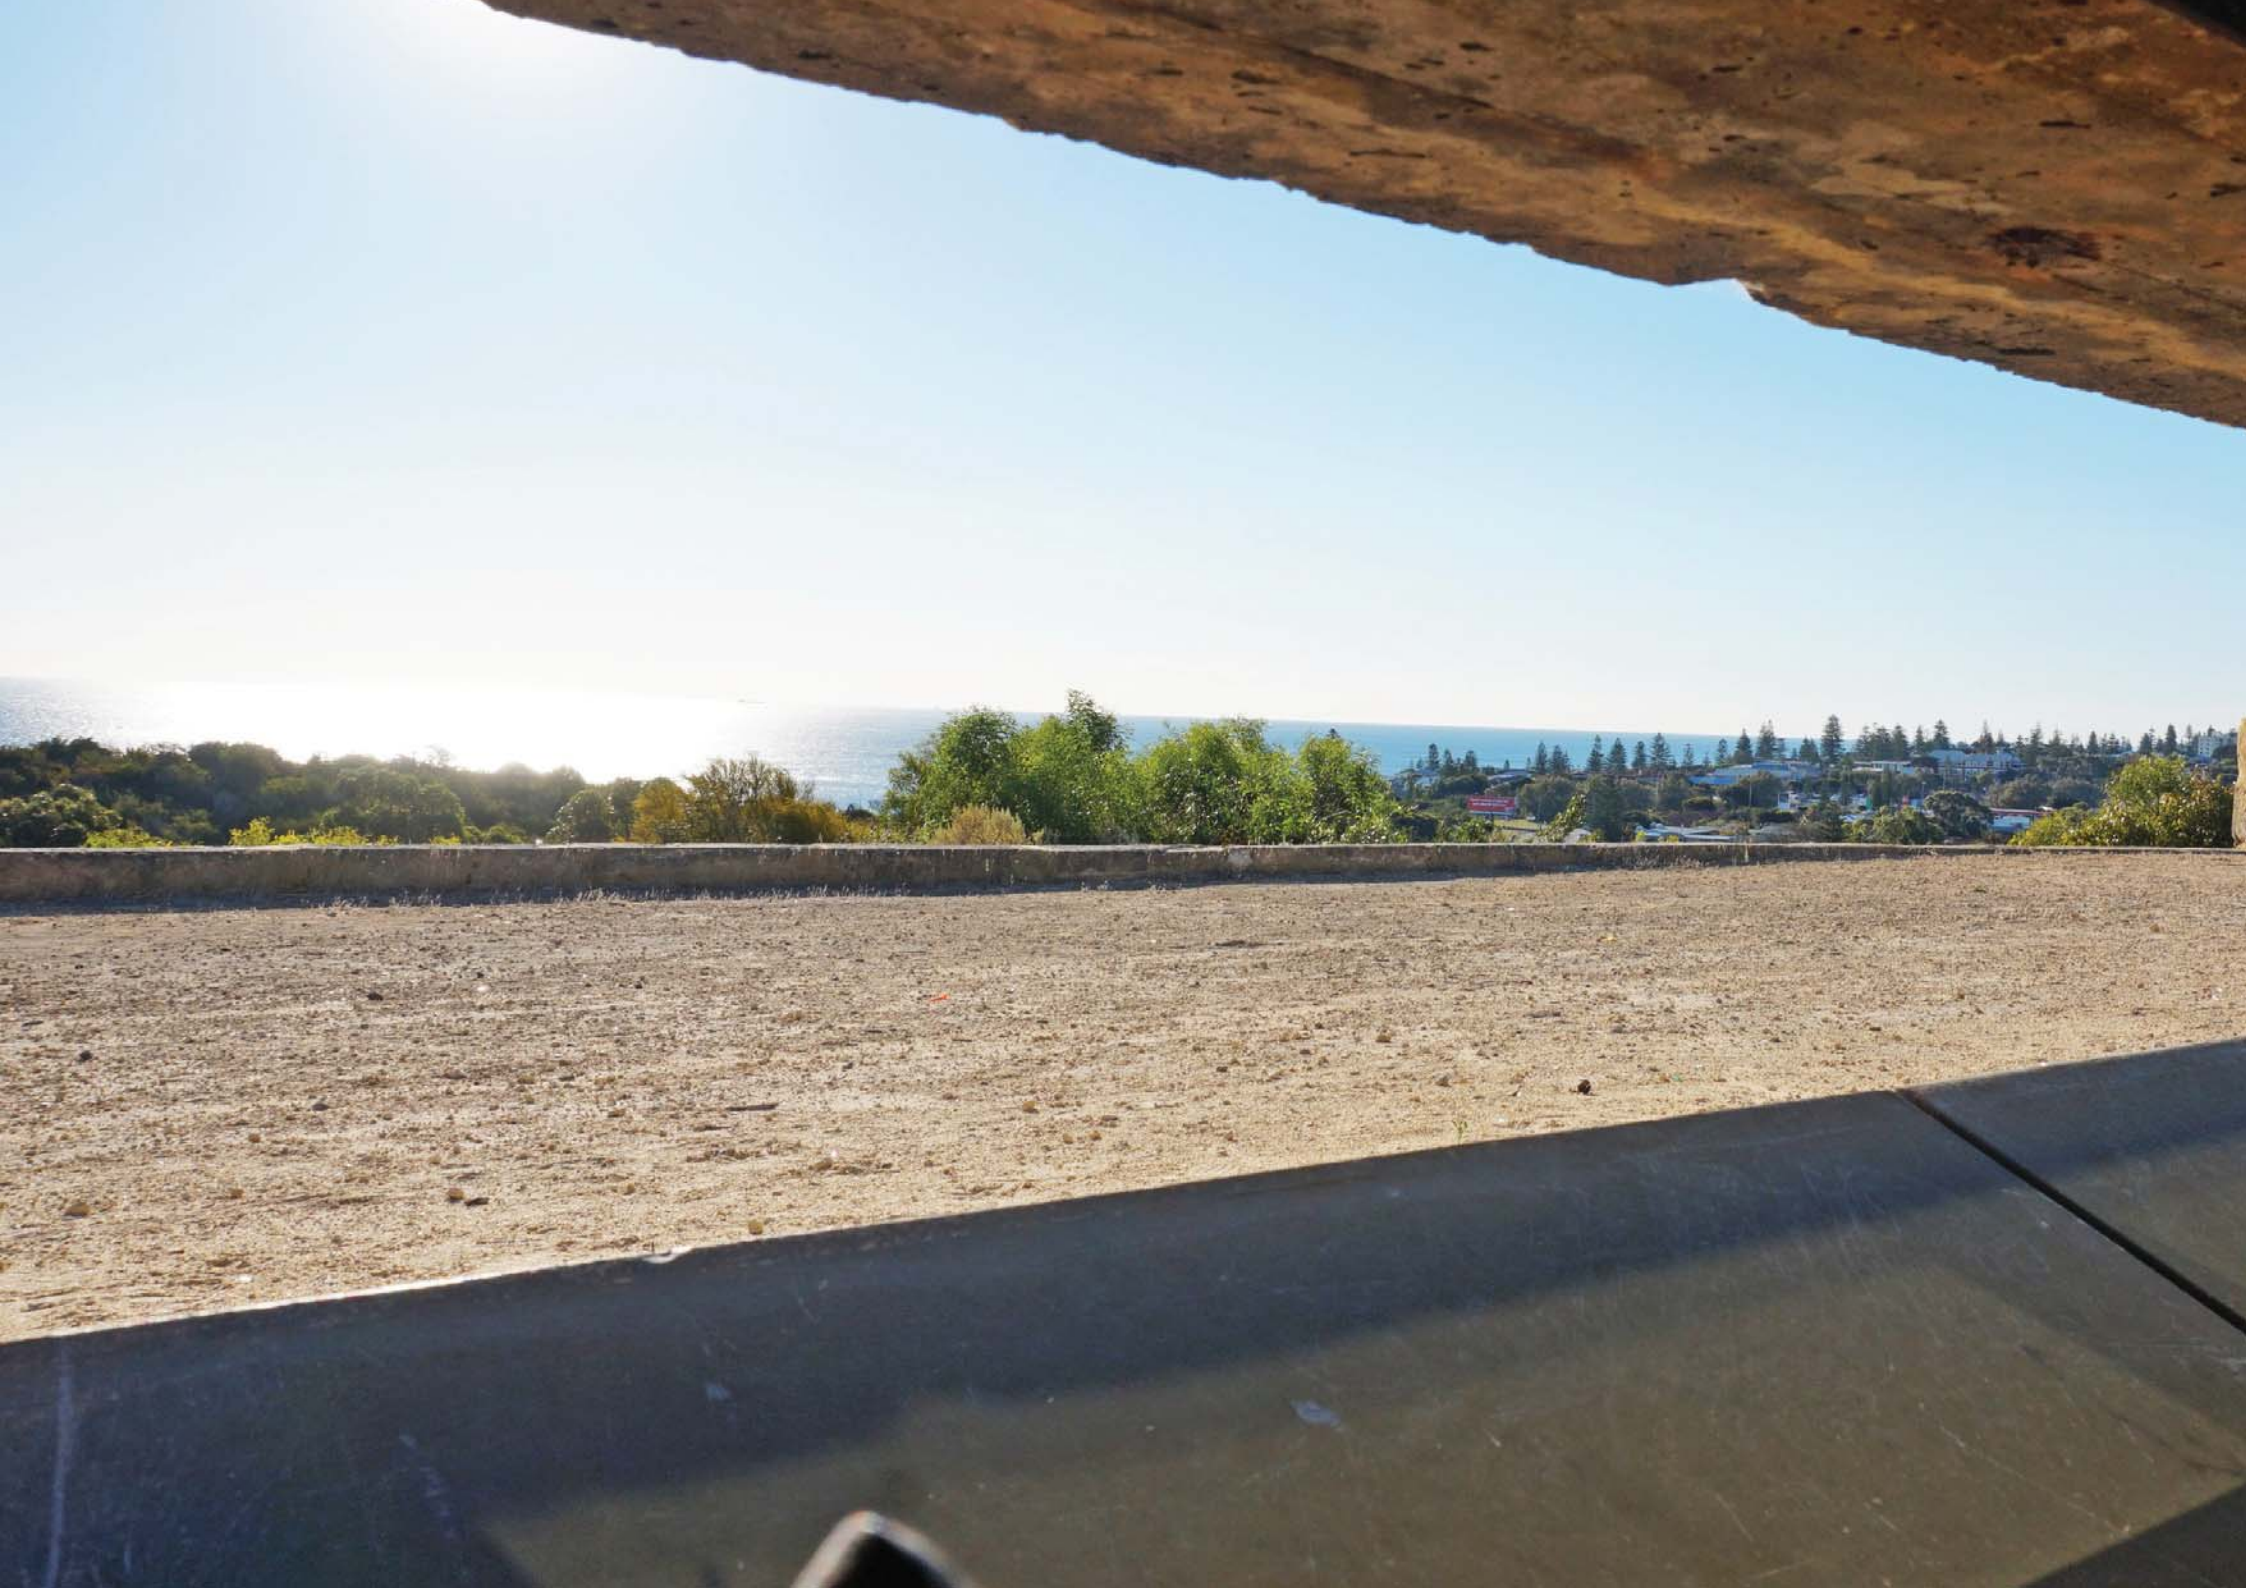
# TAWAY DIAGRAM OF A 6 inch Mk7 WIREWOUND GUN BARREL

JACKET  
WIRE WINDING  
'A' TUBE

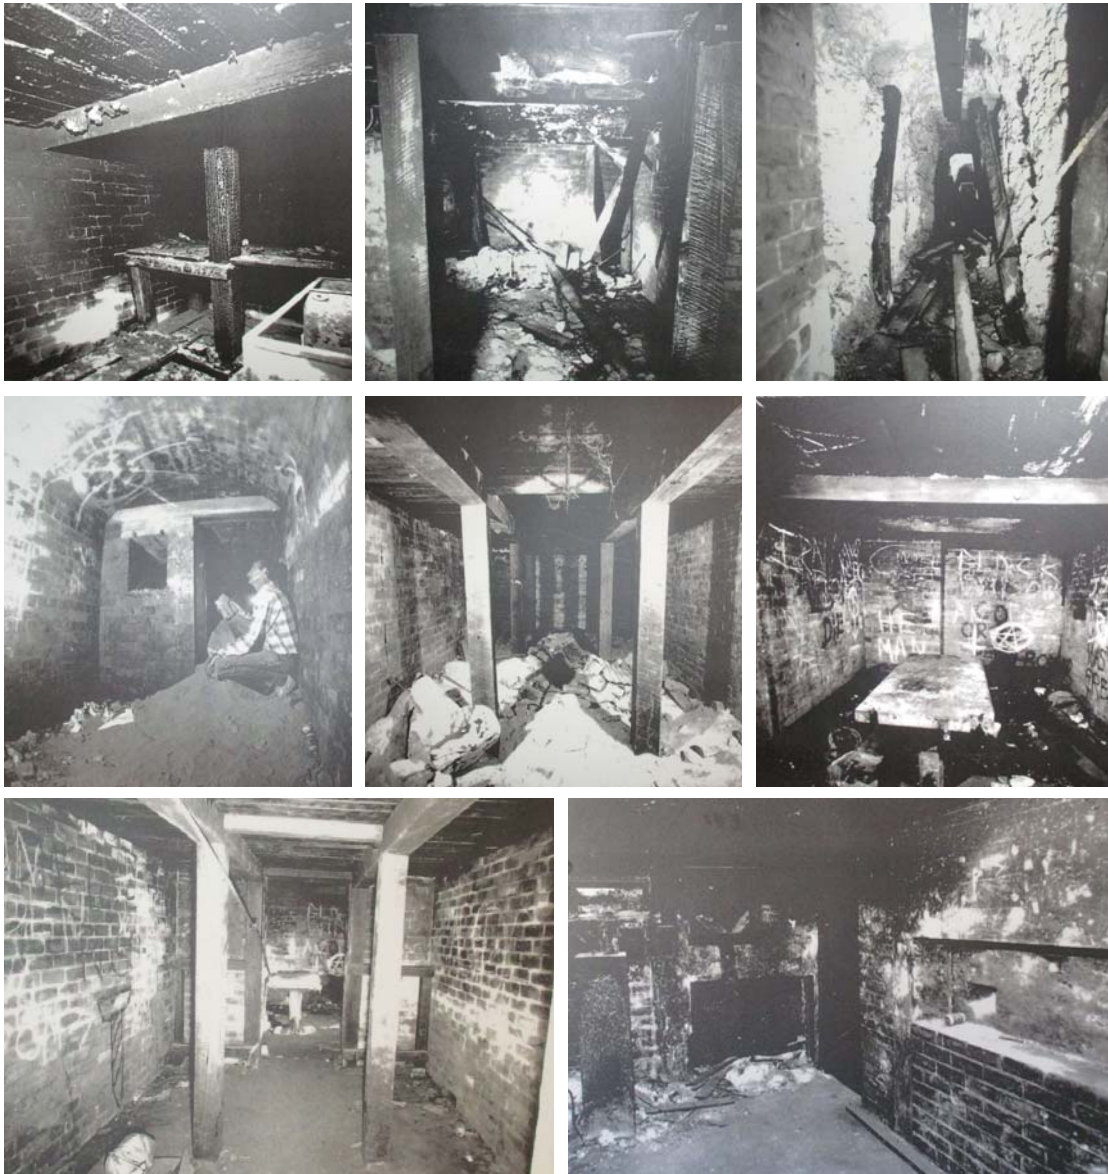
Figure 66. Royal Australian Artillery Historical Society of Western Australia, "Leighton Battery Tunnels", c.1989

Developers worked with the Royal Australian Artillery Historical Society to manage the preservation works of the Leighton Battery tunnels. These works included the “clearing of rubble, smoke damage and graffiti from the tunnels, conservation of one gun emplacement, the reconstruction and securing of tunnel entrances, and the installation of electrical services.”<sup>57</sup> Although three 5.25” gun emplacements existed on the Leighton Battery site, only the northernmost was uncovered and conserved as part of the development works. These works commenced in May of 1989 and continued through until 1990 with the installation of steel doors to the entrances, removal of burnt timbers, and the replacement of windows to the command post. Works also saw the southern emplacement removed entirely while the centre emplacement remains buried on the site. Figure 66 demonstrates the extent of the damage to the site prior to these works.

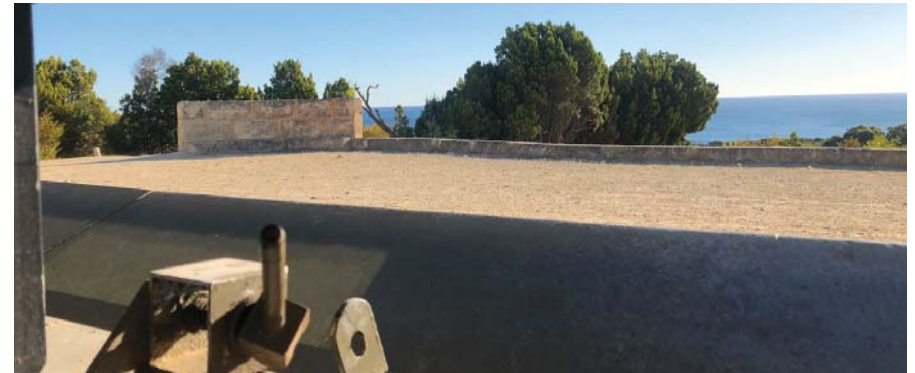
Figure 77. View from the Observation Post. Please note limestone wall to be demolished. View from the Observation Post. Please note the limestone wall and vegetation are blocking significant views. Wall noted as intrusive and to be removed and vegetation to be pruned accordingly (element, 2019)

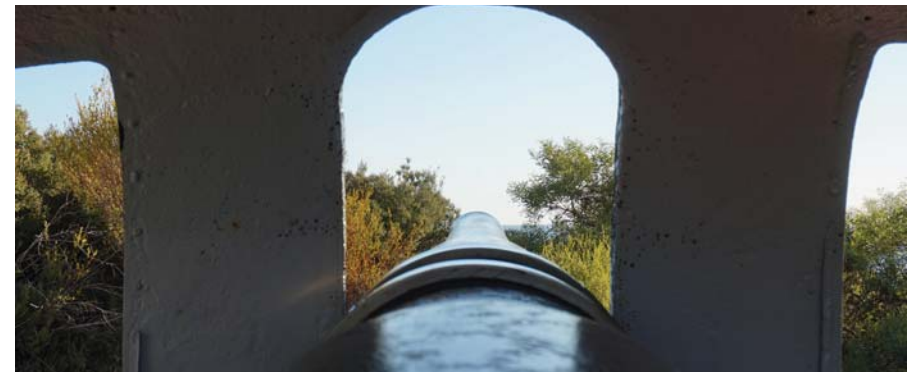
Figure 78. View from the reconstructed 6" gun. Please note the vegetation blocking significant views to the Indian Ocean. (element 2019)

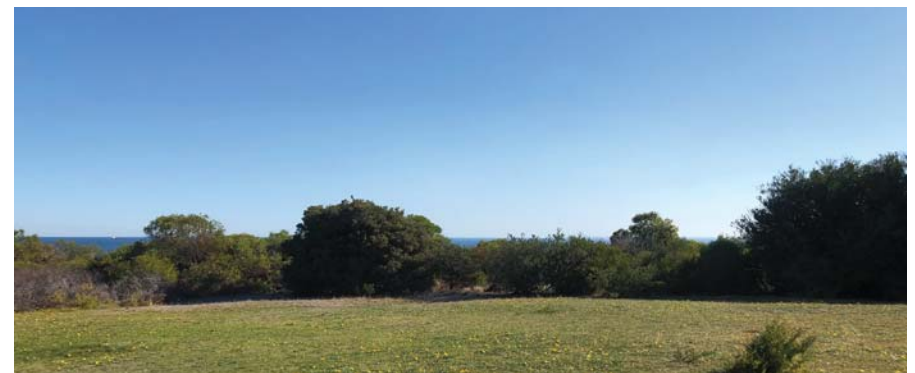
Figure 79. View from uncovered 5.25" emplacement. Please note intrusive chain link balustrading. (element 2019)

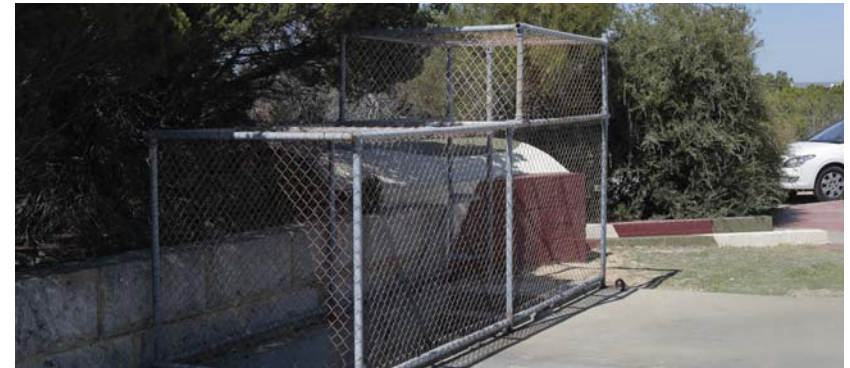
Figure 80. View of entry to 5.25" emplacement. Please note intrusive chain link fencing. (element 2019)

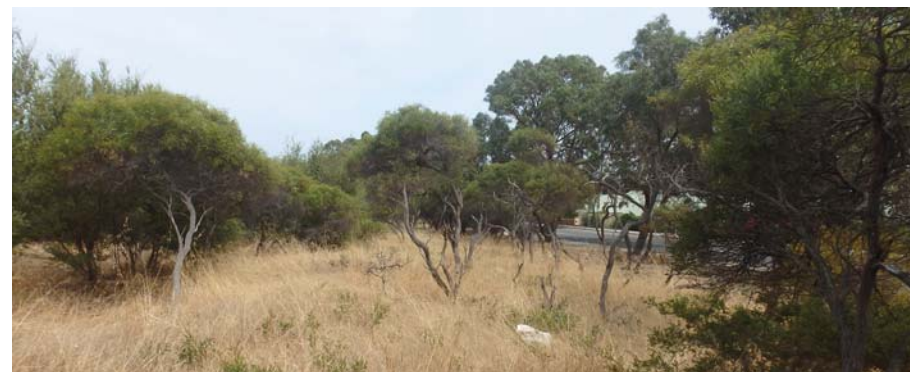
Figure 103. Vegetation in 'degraded' condition in the site (Emerge 2019).

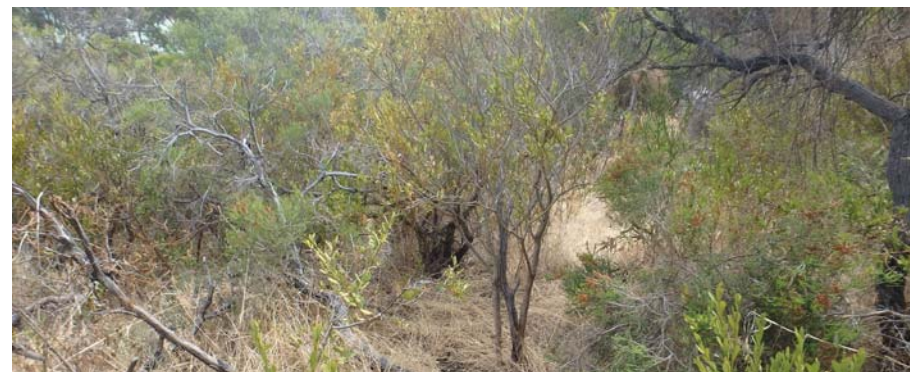
Figure 104. Vegetation in 'good' condition in the site (Emerge 2019).

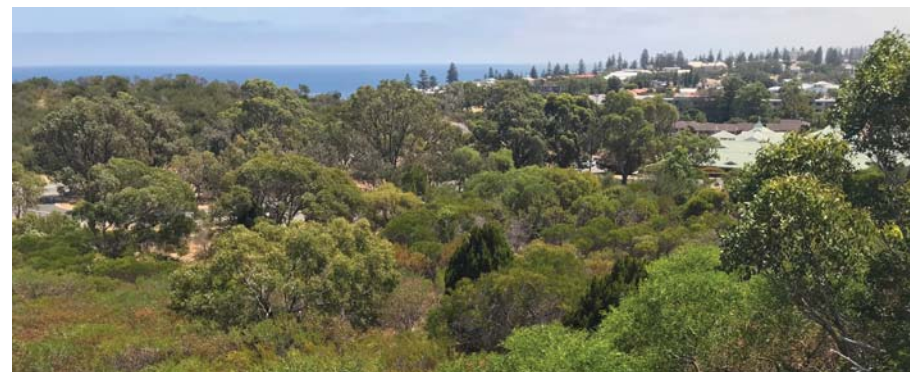
Figure 105. Vegetation in 'very good - good' condition in the site (Emerge 2019).
